# Tackling the performance gap between design intent and actual outcomes of new low/zero carbon housing

## Abstract

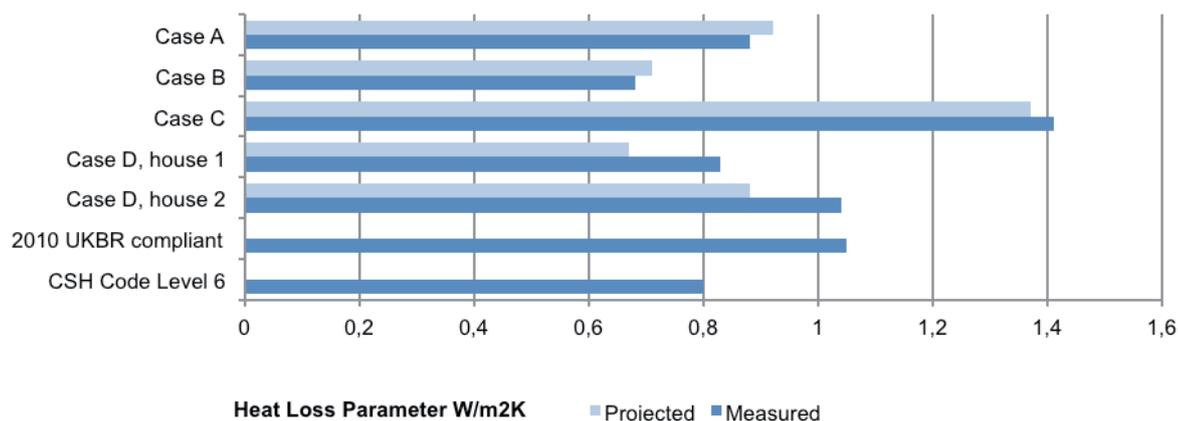
The findings from the BPE projects showed that overall there is a gap between SAP calculated and predicted Heat Loss Coefficients (HLC) and actual measured HLC. For Cases A, B and C this gap is relatively small compared to the homes in Case D. Case D had serious issues with detailing and higher U-values than designed. Figure 2 shows the predicted and measured Heat Loss Parameter (HLP) for each case study home and compared them to UK regulatory standards. The HLP is the HLC

normalised against the area of the home so that the values can be comparable. All homes but Case C would have a HLC compliant with 2010 Building Regulations and only Case B would achieve CSH Level 6.

Figure 2. Heat loss parameter for tested case study homes compared to UK regulatory standards. The 2010 UK Building Regulations (UKBR) compliance figure is based on SAP calculations using a two-storey detached house with an area of 105 m<sup>2</sup> (GHA, 2011). CSH requires a minimum HLP of 0.8 W/m<sup>2</sup>K to achieve a Level 6 designation (Gaze et al., 2009). The SAP projected HLC values do not include mechanical ventilation so that they may be comparable to the co-heating methodology which requires that all ventilation is sealed.

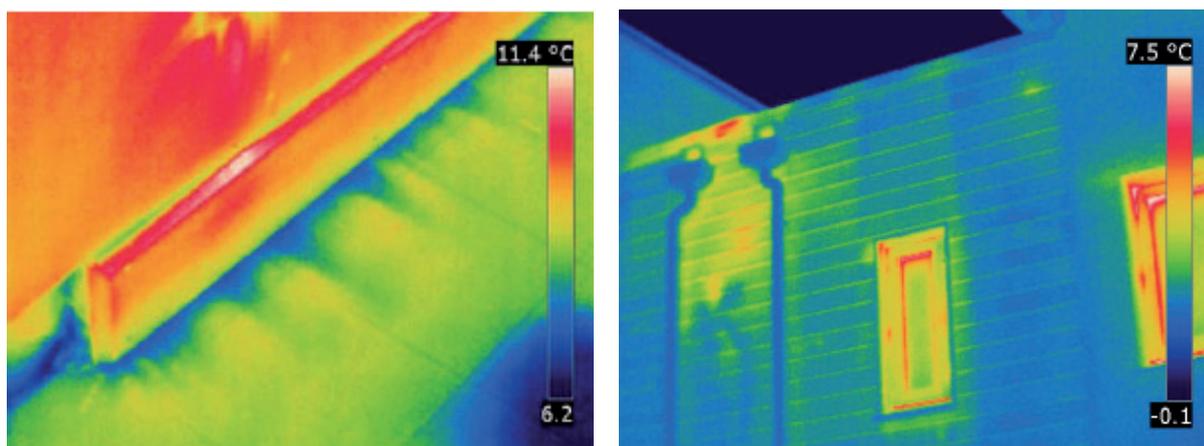
To further contribute to discrepancies between calculated and measured, all homes showed significant levels of heat loss through party walls following heat flux tests. Cases A and B showed similar results with around 2.8 % of total building heat loss being lost through the party wall. In Case A, the clear weak point was heat loss through the floor (Figure 3, left). Case C exhibited the greatest percentage of total heat loss through the party wall at 7.9 % of total house heat loss. The measured heat loss was found to be 67 times greater than theoretically expected based on the SAP party wall U-value of 0.2 W/m<sup>2</sup>K. Based on thermographic analysis (Figure 3, right), the wall appeared to be poorly insulated allowing heat loss to escape through the parapet. Both design and construction requires greater understanding and attention to detail with regard to thermal bridges and party walls.

Figure 3. Thermographic images of heat loss through the floor / wall junction of the party wall in Case A (left) and heat loss through the parapet junction of the party wall in Case C (right). Note: the left image shows unfinished skirting board along the floor.

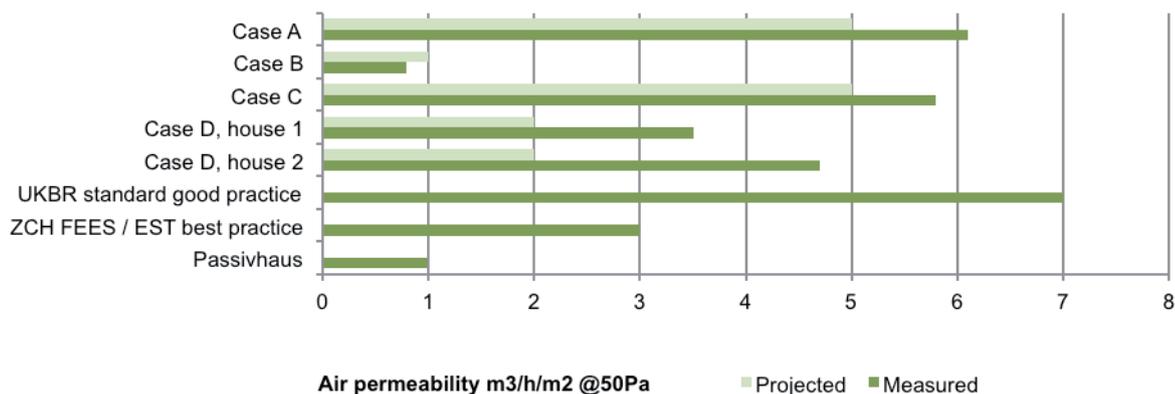
concern is in Case D, where both homes missed the target by a large amount, especially Case D.2 with air permeability over twice as high as expected (Figure 4). Apart from the construction quality, most likely the built-form, i.e. end-terrace, of Case D.2 contributes to the discrepancy between the measured and designed air pressure values. Case B performed exceptionally and based on observation, even still could have improved further with more care taken around windows and door threshold seals. The results achieved by Case B undoubtedly benefited from the modifications to the original design in response to concern for thermal bridges and air tightness. In Cases A, C and D, better air tightness would have resulted from a higher quality of detailing at key junctions, skirtings and service penetrations. Specifically, for Case D, air leakage was found in a number of places: through penetrations in ground floor bathrooms, electrical cupboard, solar and MVHR cupboards, below skirting boards and around external doors on the ground floor. All cases would have benefited from more detailed care around door and window thresholds and seals and service penetrations. The roof gables were also weak points for some homes. Air permeability test failures can result in delayed handover, time and payment disputes and costly remedial works. Some air leakage pathways are extremely difficult and expensive to fix.

Figure 4. Air permeability for tested case study homes compared to practice standards.
