# **Field Monitoring of the Hygrothermal Performance of Interior Basement Insulation Systems**

*Kohta Ueno, University of Waterloo  
Aaron Townsend, Building Science Corporation*

## **ABSTRACT**

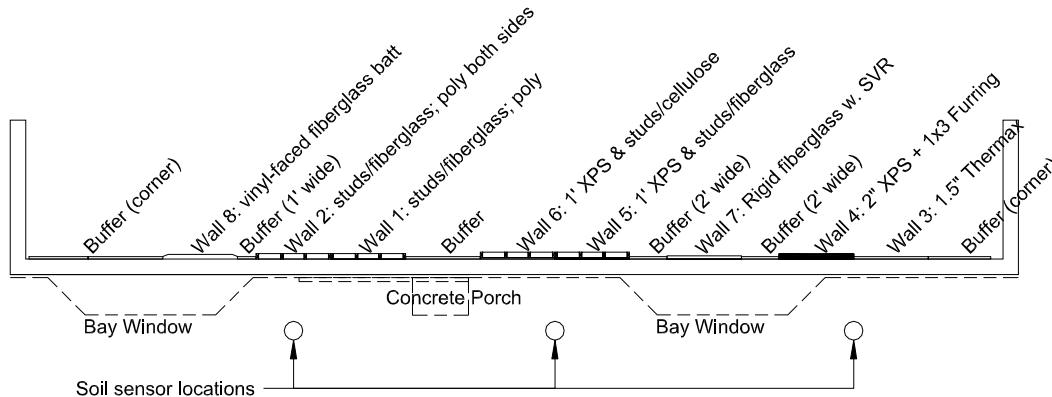
**Figure 1. Test Panel and Soil Sensor Locations**

Four-foot wide, full-height insulation test panels were installed on the interior of the foundation, with 1-1/2" foil-faced polyisocyanurate buffer panels between test panels. Buffers were also used in the corners to avoid temperature anomalies in the test panels. The three remaining orientations of the basement were left uninsulated. Panel edges were air sealed to reduce lateral air leakage and thermal edge effects. Southern solar exposure of the above-grade portions of the walls is minimally blocked by vegetation, but is reduced at the bay windows, shading certain test panels. Figure 1 shows the test layout.

Interior and exterior temperature and relative humidity were recorded. In addition, soil temperatures and water potentials (relative wetness) were measured at three lateral locations approximately two feet away from the test wall, as shown in Figure 1. Water potentials were measured using gypsum soil blocks. These sensor packages were installed at three depths (6"/150 mm, 12"/300 mm, and 36"/900 mm), for a total of nine locations. Hourly data was recorded by a Campbell Scientific CR10X system and retrieved with periodic remote downloads; occasional gaps in the data are seen, due to either sensor or logging system failures.

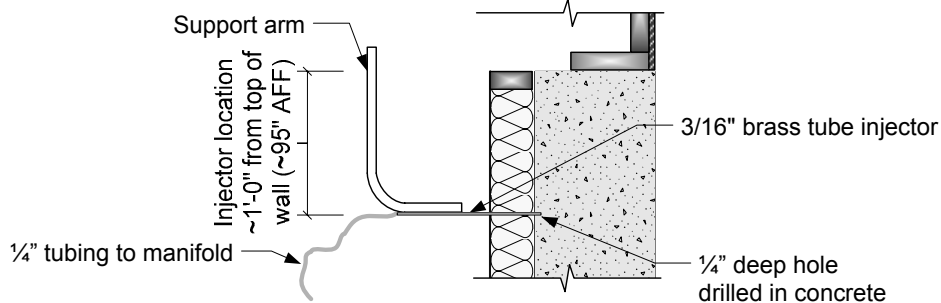
**Figure 2. Wetting System Injector Detail**

A system that introduces controlled amounts of water into the walls was installed to evaluate the drying behavior of the wall assemblies; it was operated in the second year of the experiment. The wetting system has a water injector at each test panel, fed by a relay-controlled pump. The goal was to equally wet all walls simultaneously; field calibration showed discharge rates within  $\pm 10\%$  of the average. The injector assembly is a small-diameter brass tube with a small opening; it was fed through the insulation assembly into a shallow (1/4") hole drilled into the concrete wall (Figure 2). The injector was located approximately 95"/2.4 m A.F.F, at the panel centerline. The intent was to simulate a water event originating at the concrete wall, such as a leak or condensation.

Wall 2 was the exception: the injector was fed into the stud bay cavity (between the polyethylene layers) instead of to the concrete-insulation interface. Although the polyethylene ostensibly isolates the frame wall from external moisture sources, failures have occurred by wetting inside the stud cavity; the intent was to provide a similar loading.

The water injection rate was experimentally determined to avoid drainage of excess water to the bottom of the wall and out of the system, and thus was in part a function of the absorption capacity of the concrete. The protocol for each wetting event consisted of running the pump 30 seconds every 30 minutes, over 12 hours, at a flow rate of approximately 18 milliliters/minute test wall, resulting in a wetting volume of 216 ml per test wall per event.

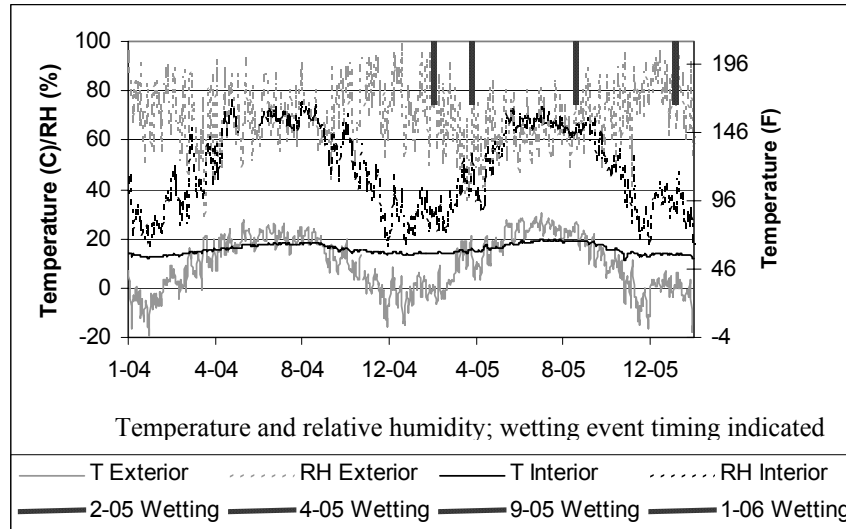
**Figure 3. Interior and Exterior Conditions (Daily Average Values)**

Indoor and outdoor temperature and relative humidity conditions are shown in Figure 3 for the two-year monitoring period. Basement interior conditions were not explicitly controlled; setpoint was maintained on the main floor of the house. Winter conditions were in the range of 55-60°F (13-15°C), 20-40% RH; summer conditions were approximately 63-66°F (17-19°C), 60-80% RH. The wetting system was used to cause four distinct wetting events, as shown in the figure.

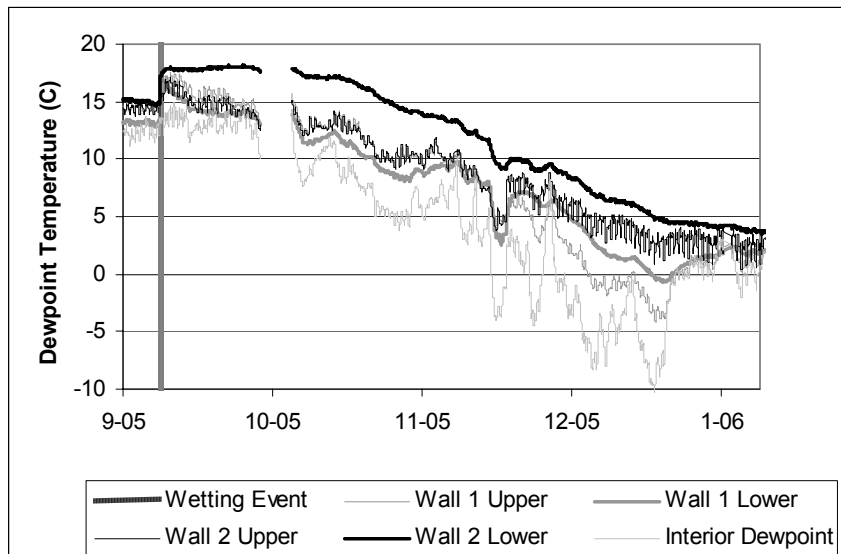
**Figure 4. Polyethylene Frame Walls (1 and 2) Dewpoint Data**

**Stud frame walls.** Figure 4 shows representative stud bay dewpoints in walls 1 and 2 (frame and polyethylene) at upper and lower locations, with interior dewpoint. The walls are responsive to interior humidity levels, suggesting that a connection exists between the stud bays and interior air, resulting in air leakage drying after wetting. Wall 1 (single polyethylene) dries faster than wall 2 (double polyethylene); wall 1 dried to interior dewpoint by the end of the period.

Differences in initial response were also seen in the frame and polyethylene walls. In wall 2 (two layers of polyethylene), water was introduced at the outer layer of polyethylene instead of the concrete; a good portion of the water drained out of the system due to the lack of storage; staining of the floor at this wall was noted during field visits.

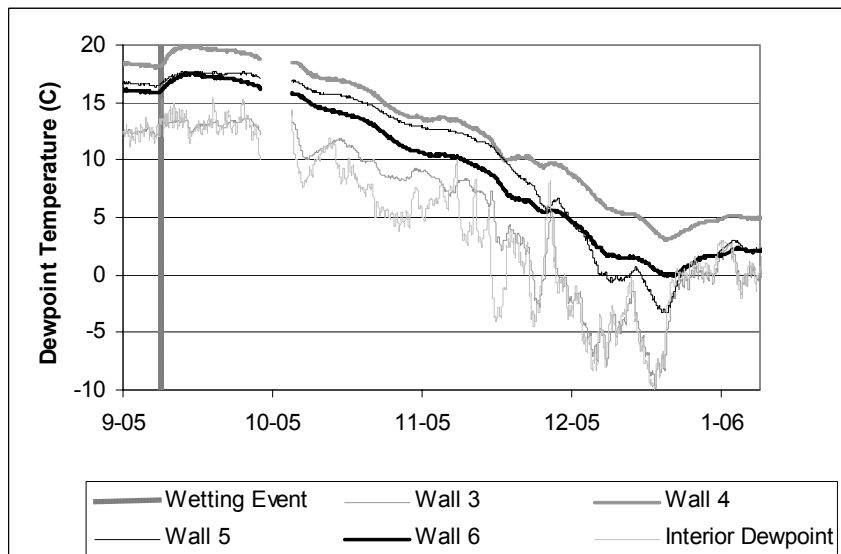
**Figure 5. Wall 3, 4, 5, and 6 Dewpoint Data**

**Foam plastic insulation walls and composite walls.** Dewpoints at the concrete-foam insulation interface are plotted for walls 4 (XPS), 5 (XPS/fiberglass), and 6 (XPS/cellulose) in Figure 5. They show similar responses: their drying is much more damped than the frame walls, as would be expected given the direct contact between the foam insulation and the hygrically massive concrete. Wall 4 dries slower than 5 and 6: a predictable result given the lower permeability of the thicker insulation. Wall 3 (polyisocyanurate), however, shows markedly dissimilar behavior: it shows a very brief dewpoint spike, then remains close to interior conditions. This is due to the air space created by the fastening system and resulting liquid drainage behind the insulation system; the other wetting events showed similar responses.

The response of the walls to the wetting system combines the effects of the moisture transport mechanisms of drainage, air movement, capillarity, and vapor diffusion. The initial wetting response reveals that construction details can have substantial effects on water accumulation and storage within a system. For instance, humidity levels in wall 3 (polyisocyanurate) dropped quickly due to the gap behind insulation, which provided drainage and air transport of moisture (vapor diffusion through the thickness of the insulation is negligible, given the two impermeable foil facers). In contrast, wall 4 (two inch extruded polystyrene) was installed with the insulation in tight contact with the concrete, creating no easy drainage gap or air cavity. The water flow was directly laterally by the tight contact of the insulation to the concrete wall and only reached the sensor by capillarity.

The XPS assembly (wall 4) had a slower drying rate than the above group; the interface between the insulation and concrete dried from 95% to 80% RH over four months. However, as a comparison metric, the humidity at the concrete interface in wall 2 (double polyethylene) remained at 100% for the entire period, even though water was never introduced at that location. This shows that drying does occur through the foam assembly.

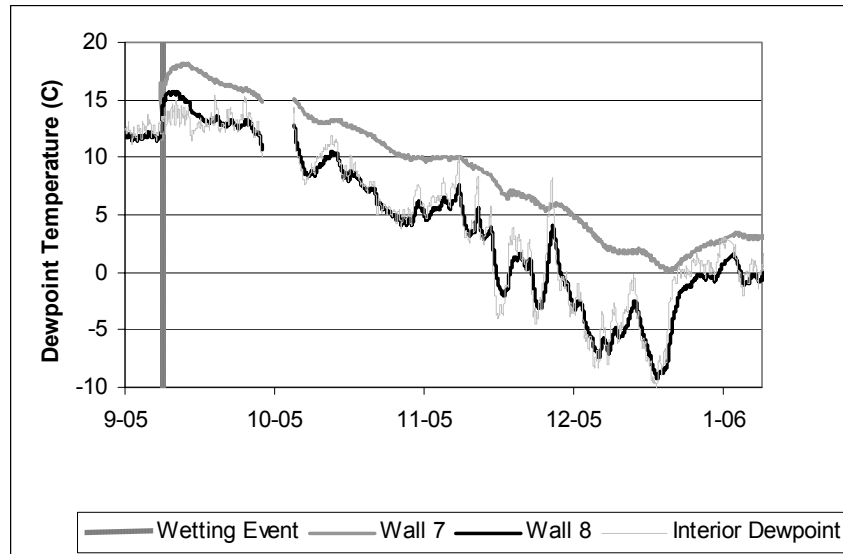
**Figure 6. Wall 7 (PA-6) and 8 (Fiberglass Roll) Dewpoint Data**

**Other walls.** Figure 6 show that wall 7 (rigid fiberglass with polyamide-6 and perforated scrim facer) behaved in a manner similar to walls 5 and 6: a damped response that slowly dried parallel to interior dewpoint. In contrast, wall 8 (fiberglass roll with perforated facer) quickly matched interior dewpoint after an initial rise: this is due to the failure of the air seal.

It was notable that wall 7 (polyamide-6) dried at a similar rate to walls 5 and 6 (XPS with frame wall and insulation). Fast drying was expected, given the humidity-responsive permeability of the polyamide layer. Calculations based on published data (Gatland 2005) indicated that permeability of the polyamide layer should rise to 80 perms immediately following this wetting event, and remain at 10 perms for most of the drying period. However, diffusion drying is restricted by both the polyamide layer and the perforated scrim. If the perforated scrim has a low permeability, it would be the limiting factor in the drying of the wall.

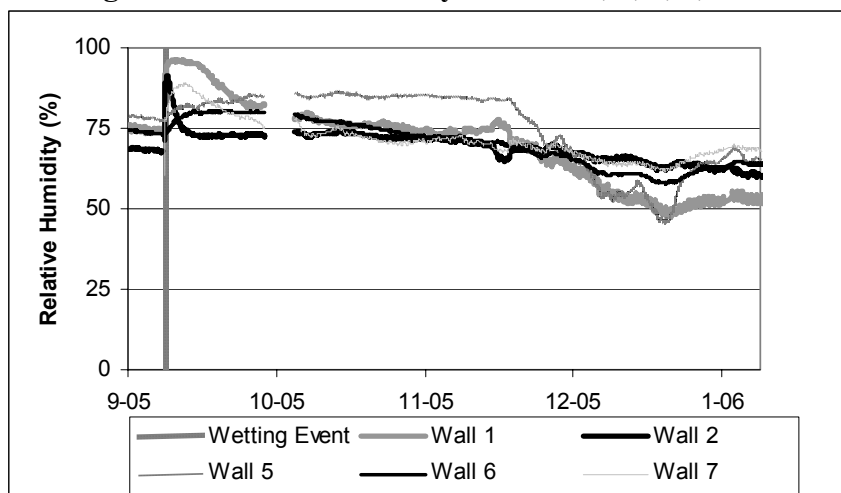
**Figure 7. Relative Humidity in Walls 1, 2, 5, 6, and 7**

The overall drying rates of the frame and polyethylene walls (1 and 2), walls 5 (XPS/fiberglass), 6 (XPS/cellulose), and 7 (fiberglass and polyamide-6) were similar (see Figure 7). Relative humidity measurements are plotted, since they are an indicator of mold growth risks. Measurements in these assemblies were in the 60-85% range for the majority of the drying period. Note that none of these assemblies stay at saturation for extended periods.

Stud bay humidity in walls 1 and 2; concrete interface humidity in 5, 6, and 7

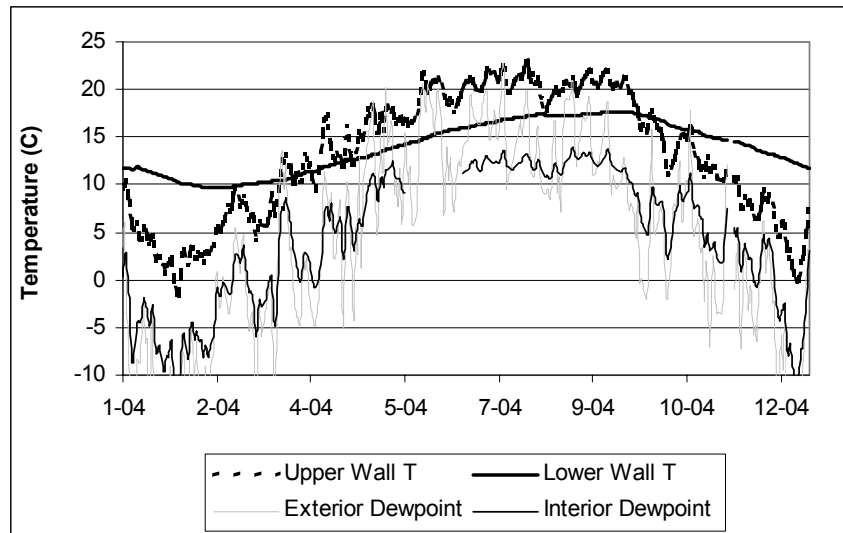
**Figure 8. Upper and Lower Concrete Temperatures with Dewpoint Data**

**Condensation risks.** Figure 8 shows the upper and lower concrete temperatures of a representative wall with interior and exterior dewpoints; measurements for all walls at a given height were close to identical. Due to a lack of interior moisture sources and summer air conditioning, the interior dewpoint is below exterior dewpoint in the summer. As a result, interior dewpoint never rises above the lower basement wall temperature; these conditions eliminate the risk of condensation at this location. However, outdoor dewpoint does rise above the lower basement wall temperature: a non-air conditioned house, or a basement with air communication to the outside, could experience summertime condensation. In addition, greater interior sources could also add sufficient moisture to cause condensation.

Similarly, interior winter dewpoint remains below the temperature of the upper portion of the concrete wall due to the lack of interior moisture sources, eliminating wintertime condensation risk. Wintertime relative humidity was equivalent to 15-30% at 70°F/21°C; operating conditions that included occupancy and moisture generation would result in higher interior dewpoints and raise the risk of condensation.
