# Innovative retrofit to improve energy efficiency in public buildings

The BRITA in PuBs project within the EU Eco-Buildings programme started in 2004 and finished in spring 2008. The project aimed to increase the market penetration of innovative and effective retrofit solutions to improve energy efficiency and to implement renewable energy technologies.

In this paper two demonstration projects are reported. The energy savings, the CO<sub>2</sub> savings and the economy of the Danish demonstration project, an old factory constructed in the 1930s and converted to a cultural centre, are described. Furthermore the constructions, the installations, the solar photovoltaic and solar thermal and the building management systems are reported.

The Norwegian demonstration project concerns the Borgen Community Centre located in a suburban area in Asker close to Oslo, the capital of Norway. The Borgen School was built in 1970 and retrofitted and converted in 2005 to Borgen Community Centre, a place for the whole neighbourhood. The main building, which is part of the BRITA project, contains

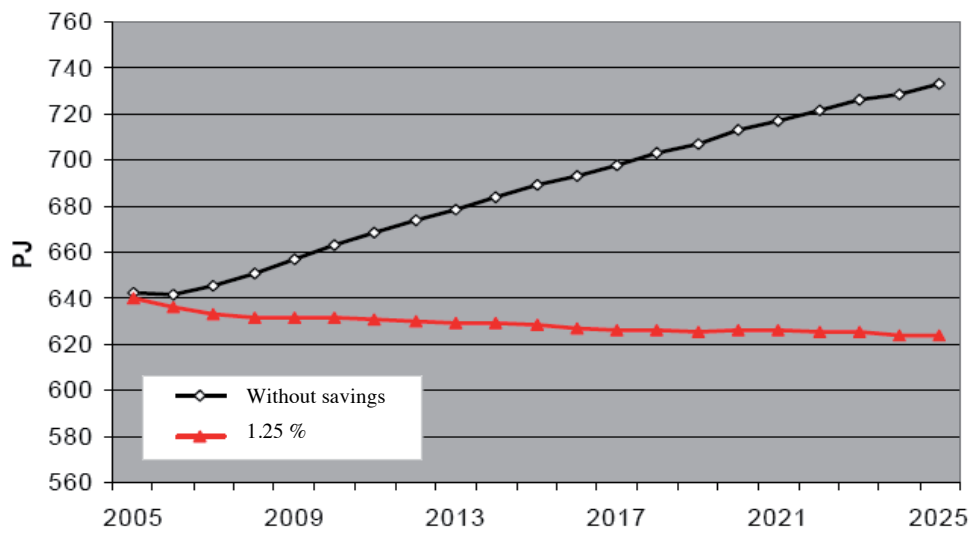
Figure 3. Total final consumption with and without energy savings in Denmark [Danish Ministry of Transport and Energy (2007)].

The aim is to achieve further savings in existing buildings. The annual savings should be increased to 1.25 % per year corresponding to a reduction of the total final energy consumption with 15 % by 2025.

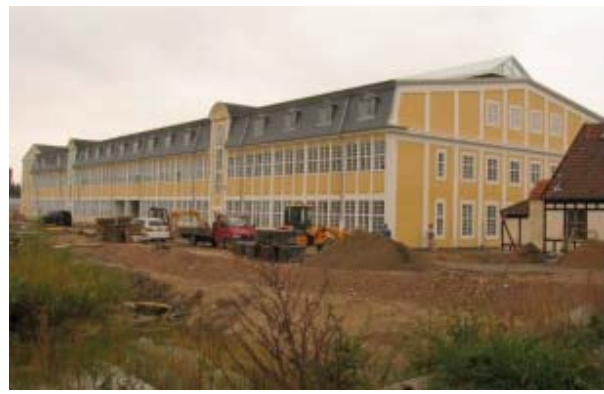
Figure 7. Ovnhallen – being retrofitted.

Originally it was the intention to insulate the external walls on the inside to keep the architectural expression of the buildings’ old brick walls. However, it turned out that for reasons of fire protection (law and regulations), this would require quite substantial and extremely costly treatment of the metal beam load supporting parts of the wall. Therefore it was decided to insulate the wall externally. This had no economic consequences for the project and from a technical point of view it was a clear advantage, as it is well known that external insulation is better at preventing thermal bridges than internal insulation.

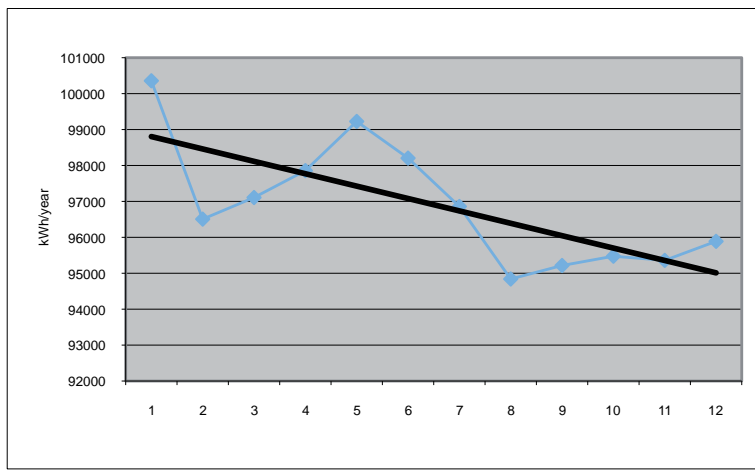
Figure 8. Monitored yearly energy consumption for space heating shown for a 12-month period from October 2006 to October 2007.

The monitored yearly energy consumption (adjusted for the average number of degree days) for space heating is shown month by month for a 12-month period from October 2006 to October 2007, see Figure 8. It shows that the energy consumption was constantly decreasing during that period by approximately 4000 kWh. The reason for the lower energy consumption was the constant fine tuning of the operation of the energy system by the energy manager.

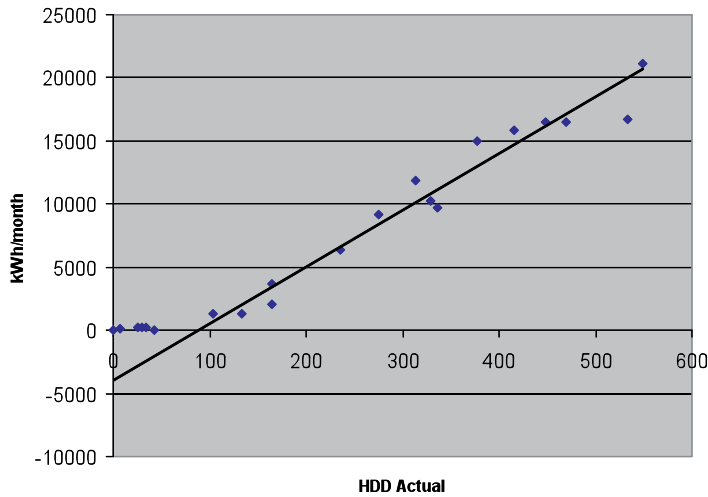
Figure 9. Monitored space heating depending on the heating degree days.

Figure 9 shows the monitored space heating depending on the heating degree days (HDD) supplied by the Danish Meteorological Institute. It shows a good correlation between energy consumption and heating degree days at the operation of the efficient energy system without unnecessary waste of energy. This perfect operation of the energy system was obtained by means of BEMS.

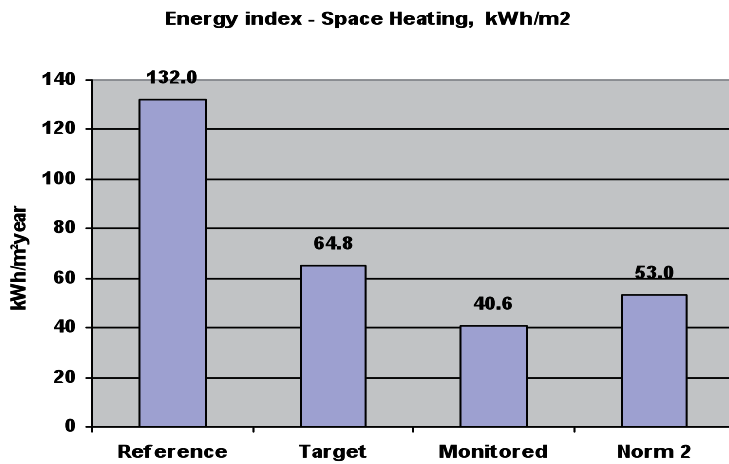
Figure 10. Building energy index.

Figure 10 shows the building energy index. The reference building energy index for space was 132.0 kWh/m<sup>2</sup> per year. The target energy index for space heating (excluding domestic hot water) was 64.8 kWh/m<sup>2</sup> and the monitored as well as the adjusted building energy index was even lower. The actual energy consumption for space heating was 18% lower than the target.

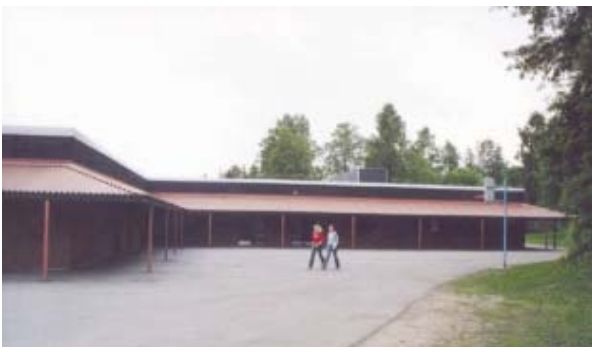
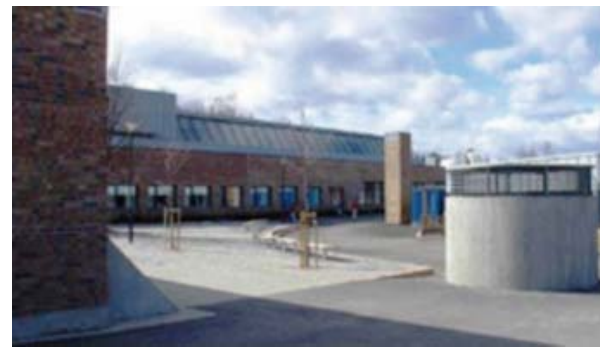
Figure 11. Pictures showing the main building before and after retrofit. The most visible features are the new daylight openings on the roof and new façades. The air inlet tower and a heat recovery unit (roof top) can be seen in the picture to the right. Architects for retrofitting: Hus Arkitekter AS. Photo left: B. Matusiak. Photo right: J. Rolland.

The most visible feature of the renewed building is the daylighting openings on the roof and the new facades. Due to new regulations on snow loads, the roof construction had to be strengthened. The roof surface had to be replaced, and this allowed the installation of daylighting openings. The windows in the facades were enlarged and upgraded with respect to thermal insulation and solar shading.

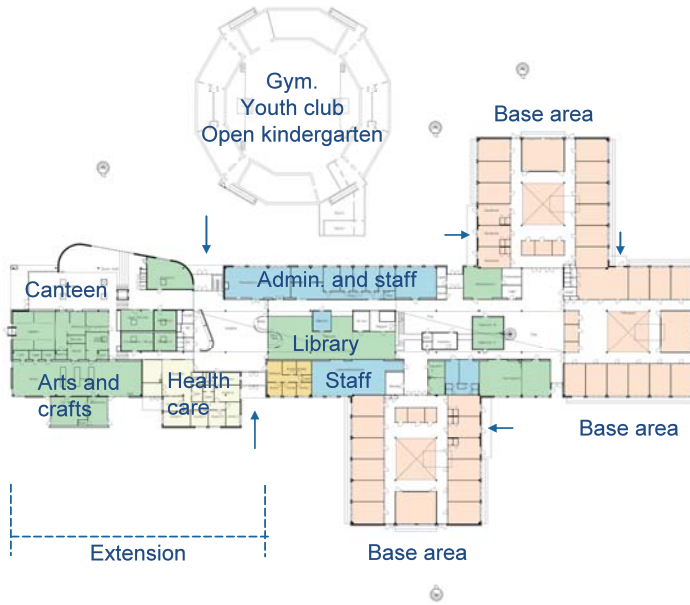
Figure 12. Plan showing the main building.

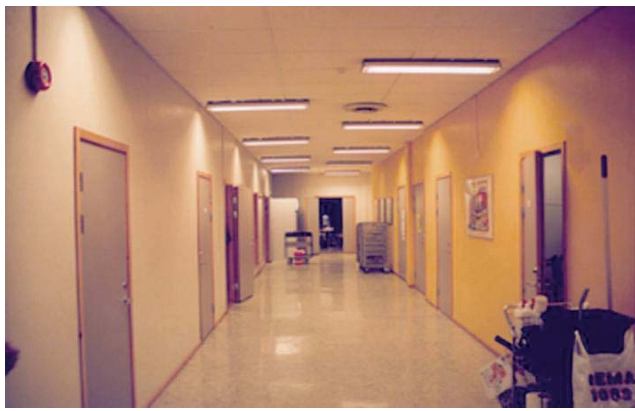
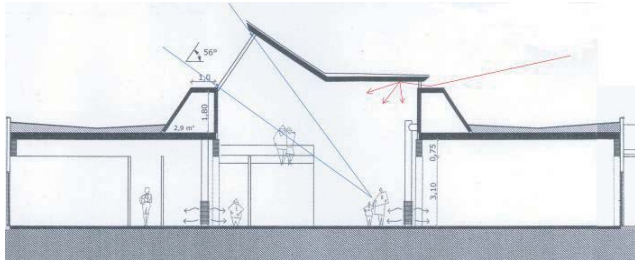
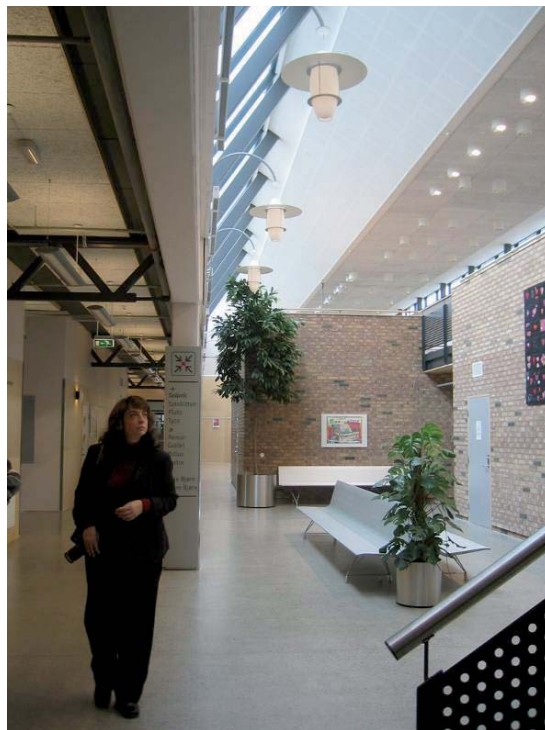
Figure 13. Pictures from Borgen Community Centre before and after retrofit.

Indoor communication area before retrofit. Photo: B. Matusiak.

Illustration: B. Matusiak [Matusiak]

Indoor communication area after retrofit. Photo: K. Buvik.

A large glass surface facing north and placed high above the floor provided a high and even daylight level in the middle zone of the building. The daylight also penetrated to the side zones through the glazing in the partition walls and increased the daylight level considerably in these areas.

to the building from the opposite direction. The roof of the ventilation duct functioned as a light-shelf.

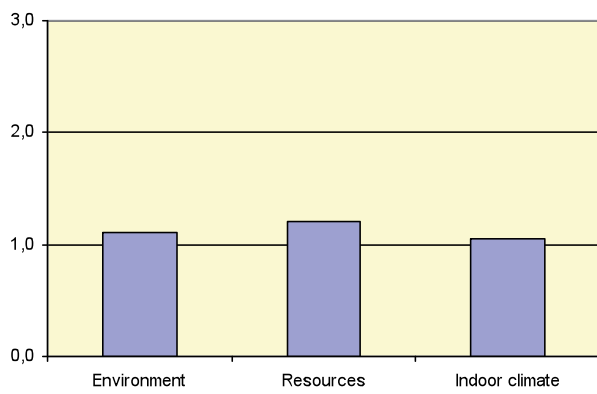
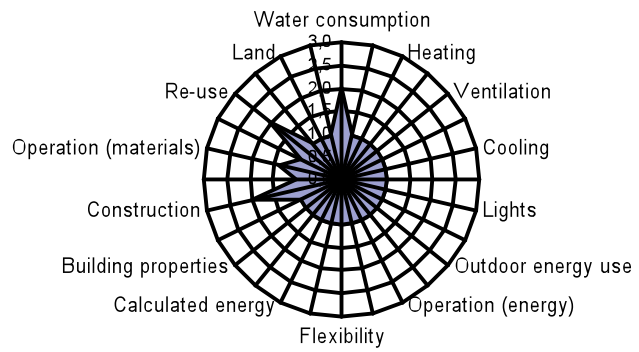
Figure 14. Results of the EcoProfile assessment. The bar chart shows the levels of the areas Environment, Resources and Indoor climate. The star diagram shows the area 'Resources' with sub-criteria. The parameters on the right side of the star, from Heating to Calculated energy, belong to the category 'energy use'. The parameters on the left side, ranging from Building properties to Re-use, deal with the characteristic of materials. Illustration: I. Andresen [Andresen].

The assessment showed that the building design performed relatively well on all environmental criteria. The bar graph shows the result of the EcoProfile analysis. The project was classified in the best category: 'low environmental loading' for all the main criteria. The star diagram allows more detailed information on the resources sub-criteria.

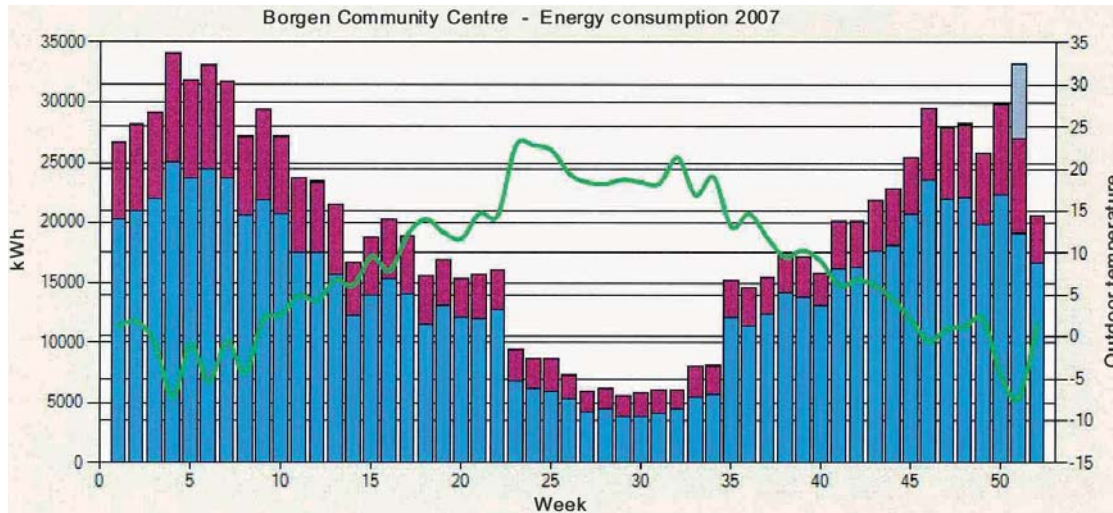
Figure 15. Total energy consumption and mean outdoor temperature in 2007. Blue: Electric power for heating and ventilation. Red: Lighting and appliances. Grey: Oil. Green: Mean outdoor temperature.

Consumption through the year is shown on Figure 15.
